## CORROSION DETECTION BY FIBER OPTIC AE SENSOR

YUICHI MACHIJIMA<sup>1)</sup>, MASAHIRO AZEMOTO<sup>1)</sup>, TOYOKAZU TADA<sup>2)</sup>,  
HISAKAZU MORI<sup>2)</sup>

### ABSTRACT

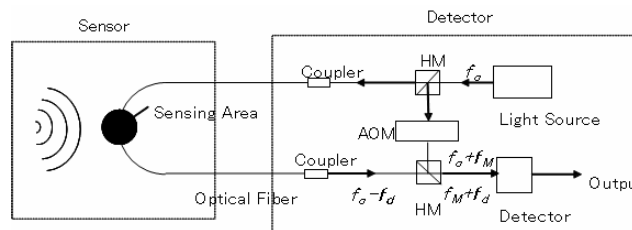
The frequency modulation  $f_d$  is detected using the machzender/heterodyne interferometry as shown in Fig.1. The laser with frequency  $f_0$  is emitted and divided into the sensing optical path and detecting optical path. At detecting optical path, frequency  $f_M$  (80 MHz) is added by AOM (acousto optical modulator) to create the frequency “ $f_0 + f_M$ ”. The difference in frequency given as “ $f_M + f_d$ ” is converted into the voltage. Hereinafter, we call this sensor “Fiber Optical Doppler” sensor or “FOD” sensor.

Fig.1 Optical interferometry by machzender/heterodyne system

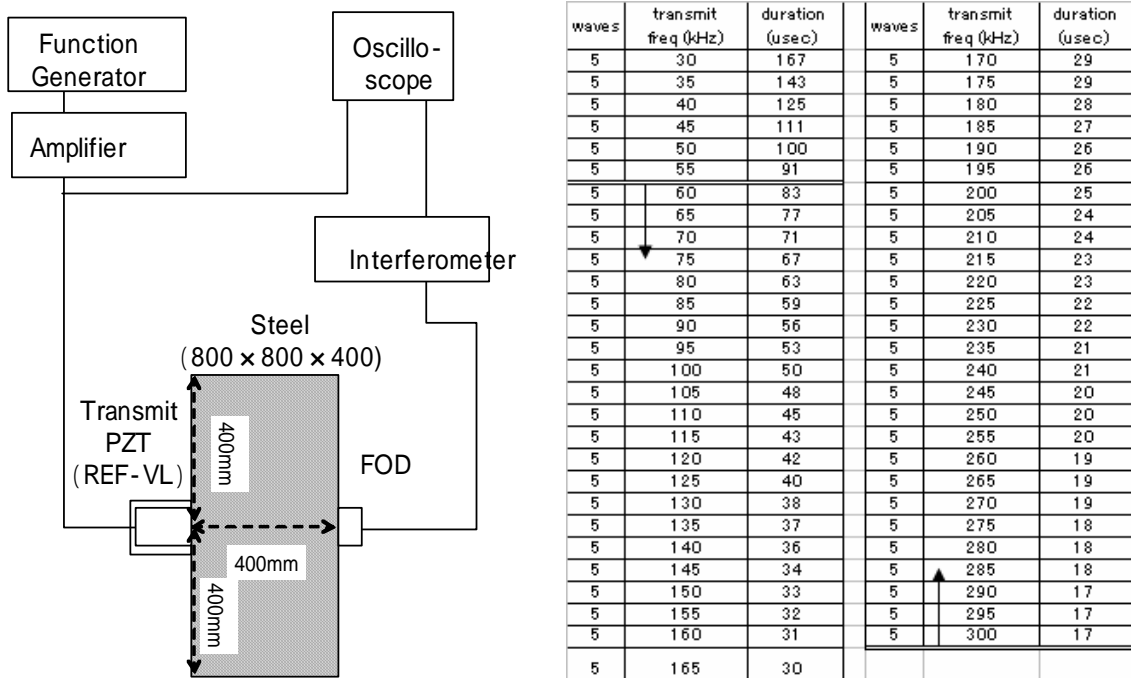
Calibration was in accordance with NDIS 2109-1991, particularly for longitudinal wave guidance. System and transmitting signal spec are shown in Fig.3. Three PZT sensors were

employed to calibrate transmitting PZT sensor initially and then replaced receiving PZT sensor by FOD sensor. Due to restricted 400mm thickness of steel cube, elimination of reflected wave (80μsec delayed at shortest distance) was carefully examined. Accordingly, frequency response from 60kHz to 300kHz was calibrated at the same number of transmitted waves (5 waves).

Fig.3 System and transmitted signal data for FOD Calibration

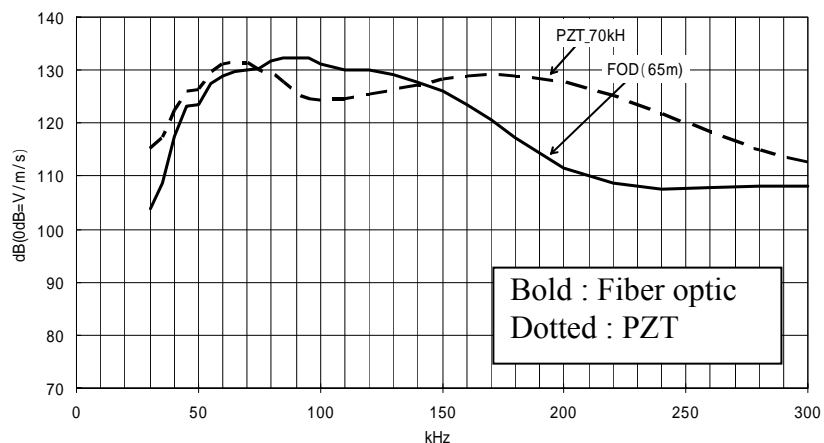
Calibrated frequency response is shown in Fig.4. As reference, 70kHz-resonant PZT (40dB amplified) sensor was also shown. 65m long/multi-layered FOD sensor has superior response to PZT sensor from 70kHz upto 140kHz. This was thought to be good for corrosion monitor<sup>2)</sup>.

Fig.4 Frequency response data

(Below 50kHz, reference only, as the number of transmitted waves is only 3)

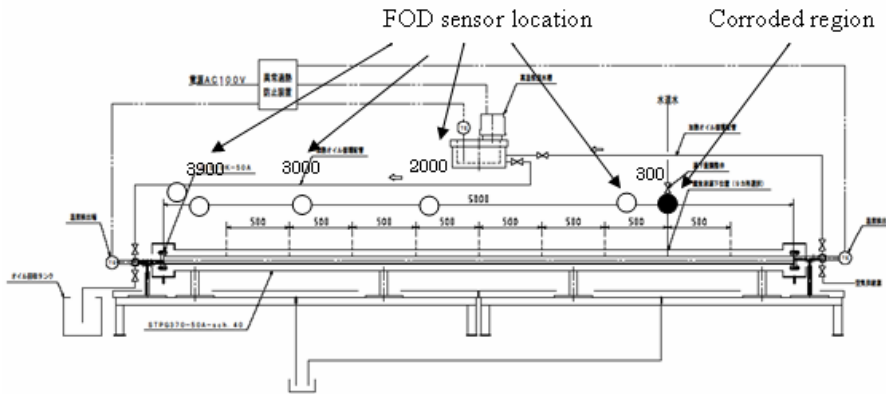
Piping mock-up is shown in Fig.5. It is carbon-steel made, 5000mm long, outer diameter 60.5mm, thickness 3.9mm (STPG-370-50A-sch.40) and has inner flow of silicon oil for heating by circulation pump. Artificial corrosion area was located 1000mm from the right edge (in Fig.5) and was accelerated by NaCl solution and cyclic heating (max. approx. 80 degrees C.). FOD sensors were located 300, 2000, 3000 each on pipe, and 3900mm away both on pipe and on welded flange. FOD sensor was installed on pipe by U-shape bolt, while directly attached on welded flange, as shown in Fig.6.

Fig 5 Experimental mock-up

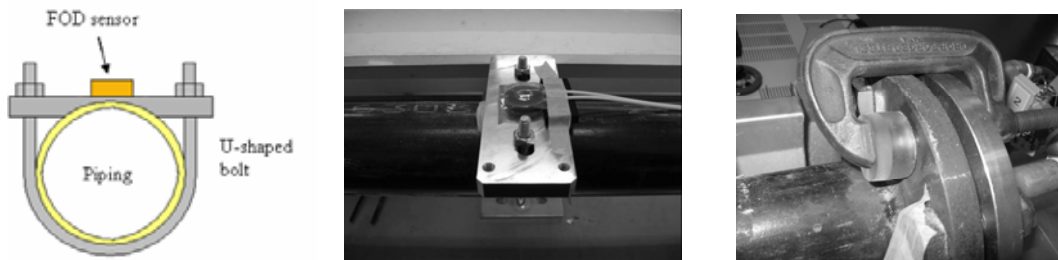
Fig.6 Sensor installation (left: on-pipe image, center: on-pipe, right: on flange)

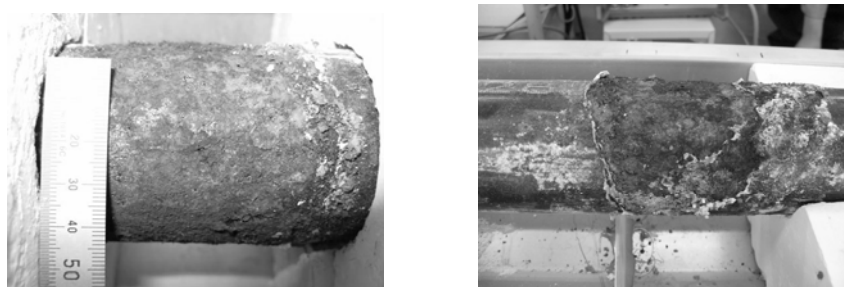
AE monitor was implemented with approx. 2 month interval for 3 times. 1st data was obtained 1 month after the start of continual NaCl drop-off. Till then, corrosion spread on surface, but peeling was not observed by eyesight. At 3rd monitor, corrosion progressed aggressively, and peeling crack was confirmed even by eyesight. Fig.7 shows corrosion of 1st and 3rd.

Fig. 7 Corrosion of pipe (left : 1st monitor, right : 3rd monitor)

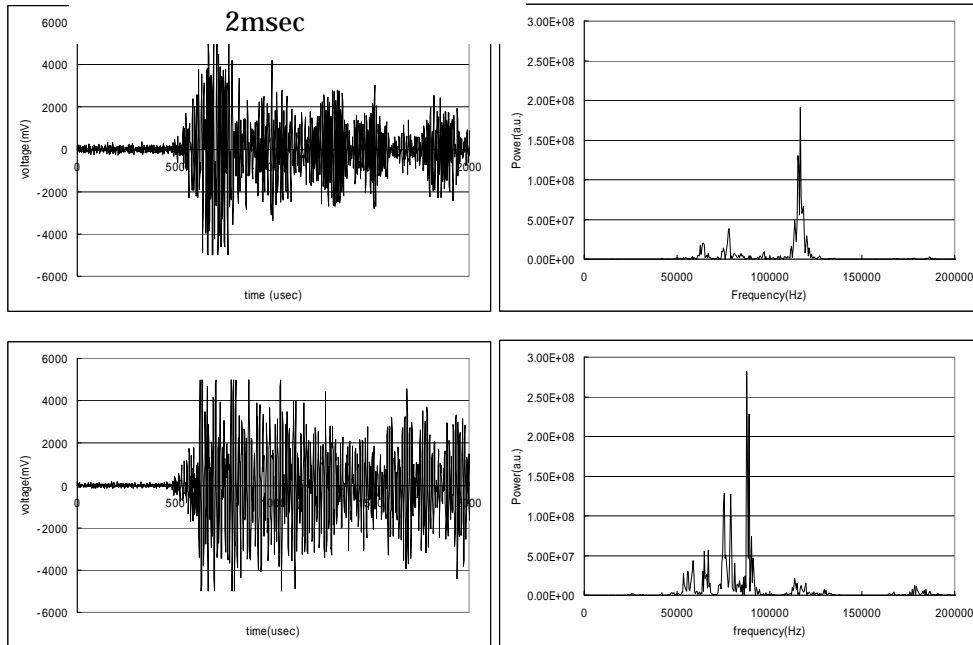
Fig 8 shows a sample of AE waves and FFT data at 1st experiment, which was obtained at 300mm away from corroded region.

Fig.8 AE waves and FFT data

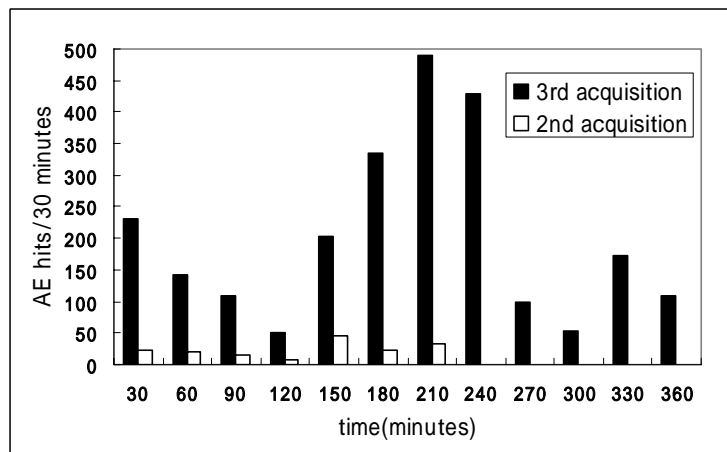
Fig.9 shows AE hits in half hour at 2nd monitor and at 3rd monitor at the same location (3900mm). Corrosion was largely activated clearly at 3rd, as confirmed by sight observation.

Fig.9 AE hits by corrosion progress at 3900mm

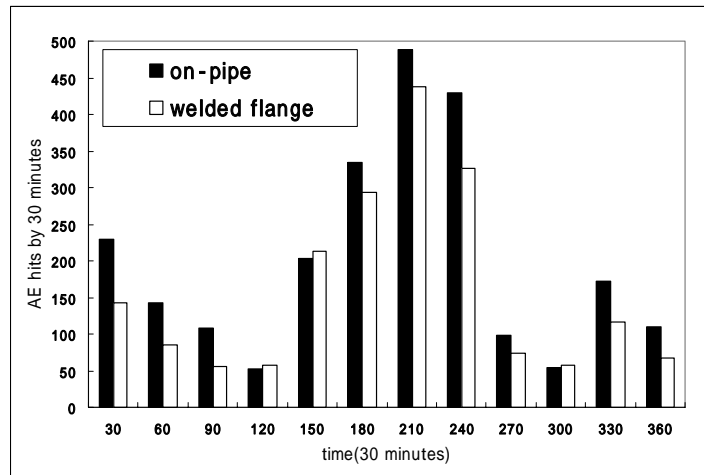
Fig.10 shows AE hits in half hour, describing whether AE data differs by sensor location between on-pipe and on-welded-flange, both are approx 3900mm away. Data clarified welded flange was relatively less in AE hits than on-pipe. This is thought to be attenuation of AE, being unable to fly over the welded joints. However, we do not see serious affect, that can give us more flexibility to install a sensor at anywhere location on piping structure.

Fig.10 AE hits by sensor location at 4000mm

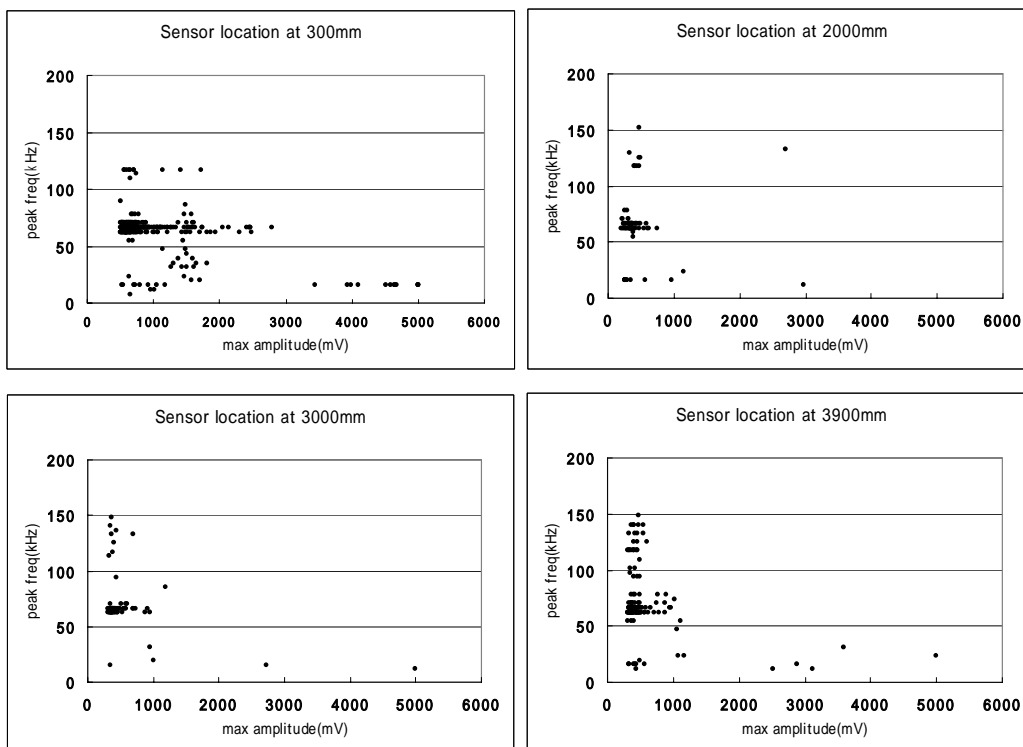
Fig.11 shows histogram of AE peak frequency / peak amplitude by sensor location. As monitoring duration of time is different from each other, the density of AE hits is not discussable here. However, it is clear that 60-70kHz peak frequency is more observed in any location, and larger amplitude is having lower frequency.

Fig.11 Peak frequency – amplitude histogram
